GEOTECHNICAL ENGINEERING STUDY

Possum Point Power Station Ash Pond ABC Dominion Resources Services, Inc. Prince William County, Virginia

Schnabel Reference 14221002.01 December 9, 2014

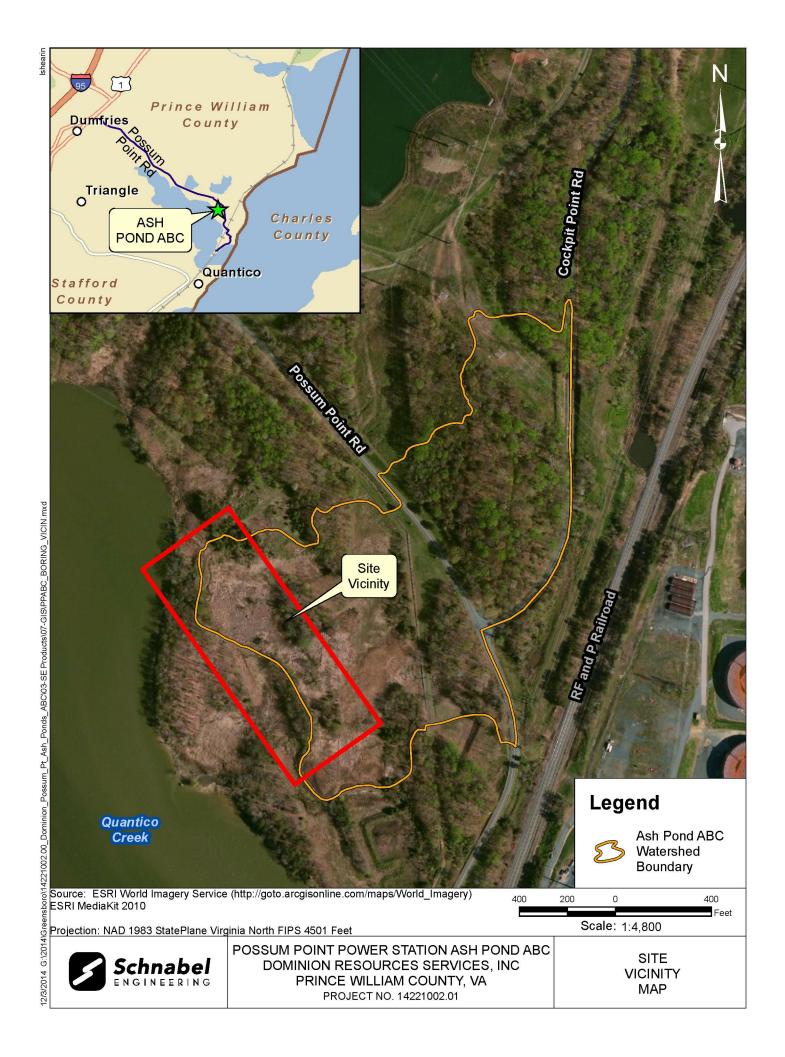
Figure 3, Regional Geologic Map

We reviewed existing geologic data and information in our files. Based on this review, the general geologic stratigraphy at the site consists of embankment fill over river terrace deposits of late Pleistocene age which are underlain by Cretaceous age sediments of the Potomac Group. The terrace deposits are alluvial soils that typically consist of a mixture of clay, silt, sand and gravel. These soils typically exhibit moderate strength and compressibility. Portions of the Pleistocene age alluvial deposits have been eroded and replaced with more recent alluvial soils deposited by Quantico Creek and its tributaries. The portion of the Geologic Map of the Quantico Quadrangle in Prince William County, Virginia where the site is located is included as Figure 3.

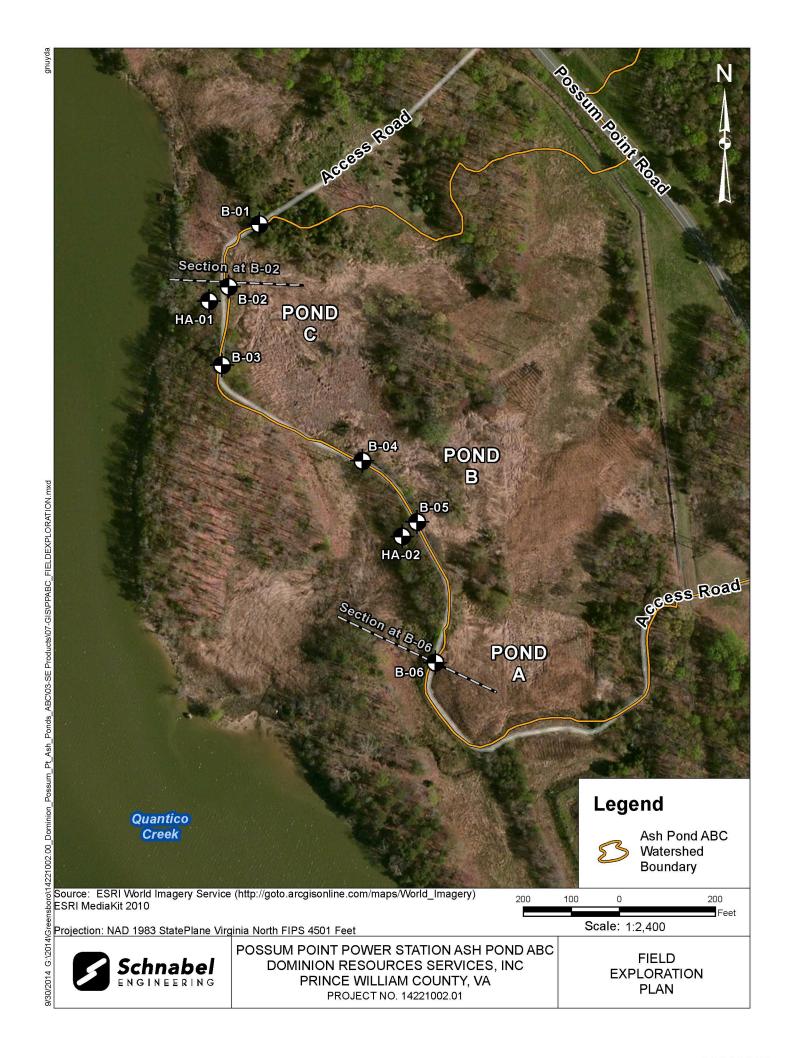
Figure 2, Field Exploration Plan

A Schnabel representative observed the field exploration, logged the test borings, and described the soils using the Unified Soil Classification System (ASTM D2488). The borings were backfilled with bentonite chips upon completion. The ground water level readings taken in the test borings are discussed in Section 3.3 of this report.

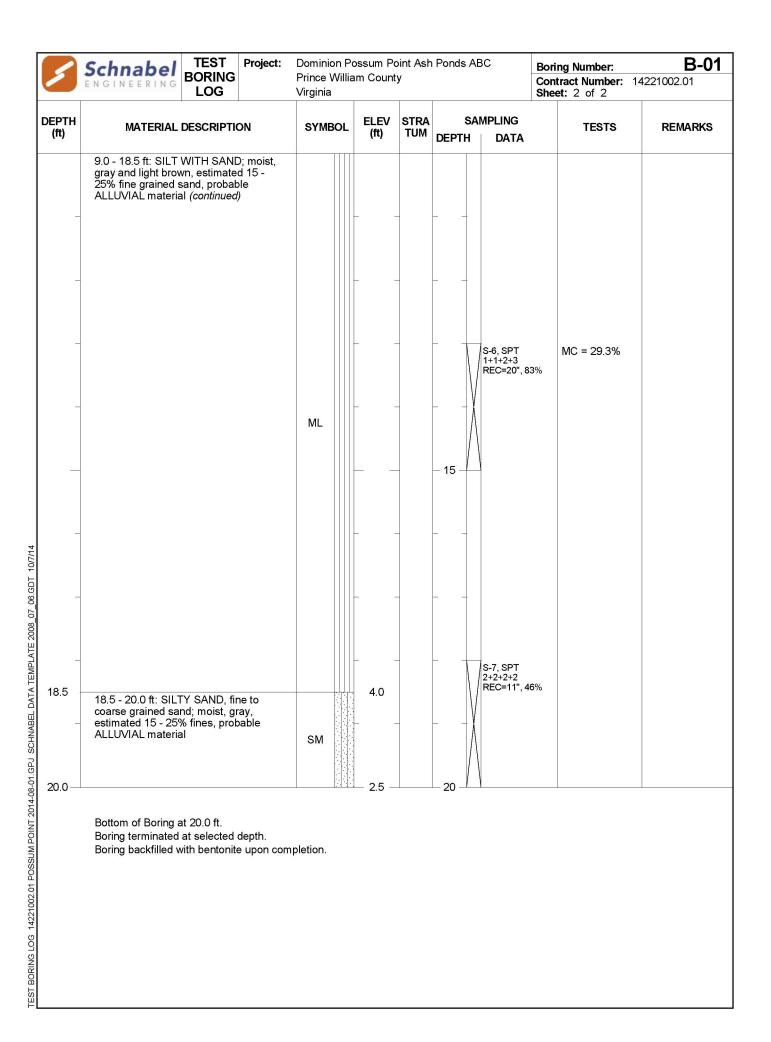
6.0	6.0 - 9.0 ft: FILL, sampled as fat clay; moist, orangish brown and gray, medium to high plasticity	FILL	- 16.5			S-4, SPT 3+5+6+10 REC=16", S-5, SPT 3+3+4+5 REC=18",	67%	: = 28.3%

9.0	9.0 - 18.5 ft: SILT WITH SAND; moist, gray and light brown, estimated 15 - 25% fine grained sand, probable ALLUVIAL material	ML	- 13.5

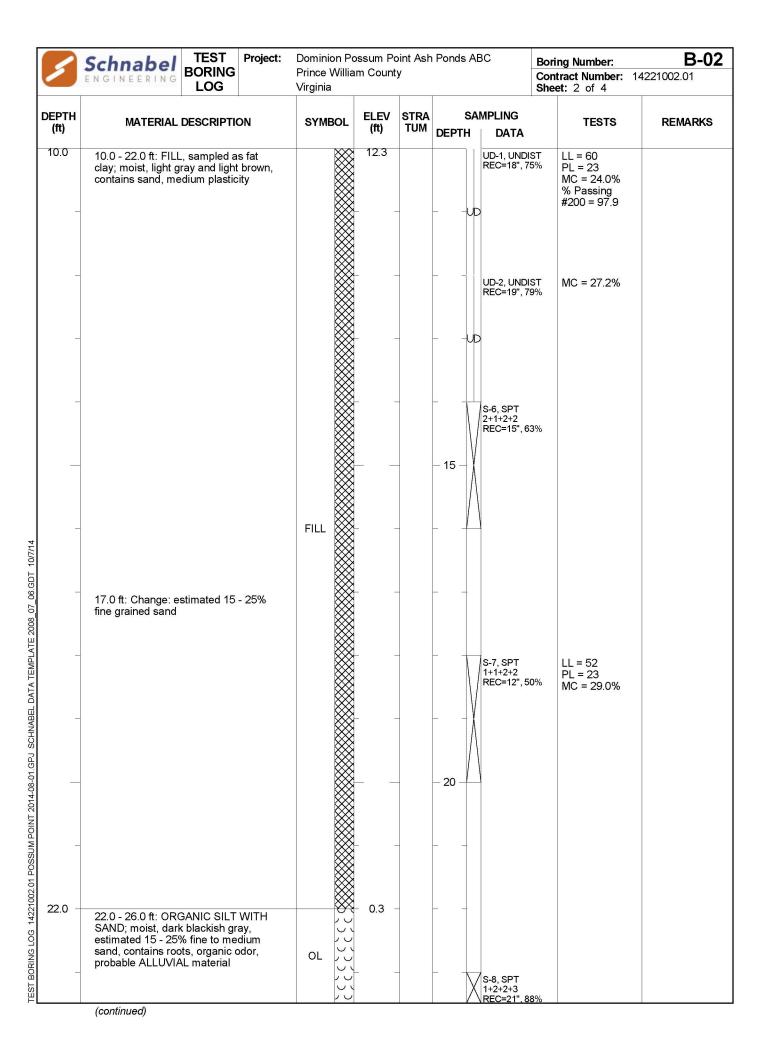
5	Schnapel Boding	Dominion P Prince Willia			Ponds AB	SC .	Boring N			3-02
	ENGINEERING	Virginia		12			Sheet:	t Number: 1 1 of 4	4221002.0	1
Contract	tor: Fishburne Drilling, Inc. Chesapeake, Virginia					Water L Date	evel Obse	rvations Depth	Casing	Cave
Contract	tor Foreman: Tim Donohue		_				00.000.00000000000000000000000000000000		Casing	
Schnabe	el Representative: Sue Buchanan		_ E	ncounte	red <u></u>	7/30/14	4:21 PM	4.0'		
Equipme	ent: CME-550X		А	fter Drill	ing 🔽	7/30/14	5:50 PM	3.1'		
Method:	4" Mud Rotary, Tricone Roller Bit		А	fter Drill	ing $ar{f Y}$	7/31/14	8:15 AM	6.5'		
lammer	Type: Auto Hammer (140 lb)									
Dates	Started: 7/30/14 Finished: 7/30/14									
	21748 ft East: 2347229 ft									
Coordina Plunge:	ate System: VA State Plane (N) -90 Bearing:

11.00		th: 45.0 ft								
DEPTH (ft)	MATERIAL DESCRIPTION	SYMBOL	ELEV (ft)	STRA TUM	SAI DEPTH	MPLING DATA		TESTS	REMA	ARKS
	0.0 - 3.5 ft: FILL, sampled as sandy elastic silt; moist, reddish brown to gray, estimated 30 - 45% fine to medium sand, contains organics, low plasticity				\ /	S-1, SPT 2+4+5+7 REC=14",				
		FILL								
_					\	S-2, SPT 3+2+3+3 REC=14",	58%

- 5 -					
_	6.0 ft: Change: gray and light brown, estimated 15 - 25% sand, contains roots	FILL			/	S-4, SPT 2+2+3+2 REC=15",	63% PL MC	= 43 = 22 = 30.3%		
_							% #20	Passing 00 = 87.6		
_					\ /	S-5, SPT 1/12"+1/12 REC=16",	67%

9.0	9.0 - 10.0 ft: FILL, sampled as silt with sand; moist, dark blackish gray, contains roots, contains fine gravel, organic odor	FILL	13.3

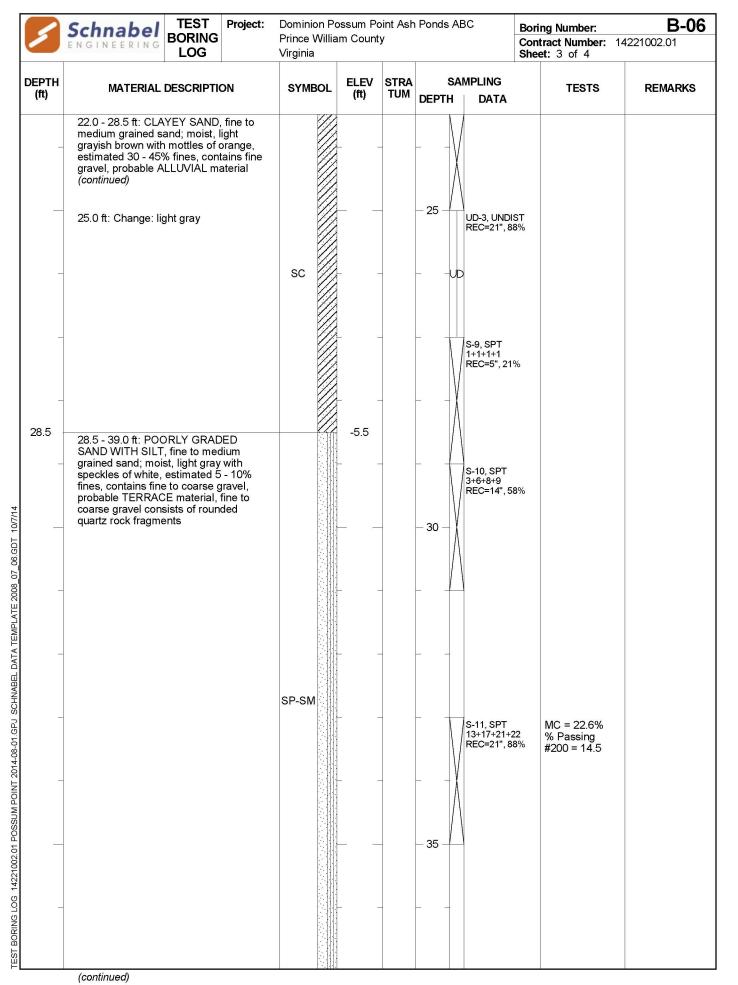
5	Schnabel TEST BORING LOG	Dominion Po Prince Willia Virginia			Ponds AB		Boring Number: Contract Number: 1 Sheet: 4 of 4	B-06
DEPTH (ft)	MATERIAL DESCRIPTION	SYMBOL	ELEV (ft)	STRA TUM	SAN DEPTH	/IPLING DATA	TESTS	REMARKS
_	28.5 - 39.0 ft: POORLY GRADED SAND WITH SILT, fine to medium grained sand; moist, light gray with speckles of white, estimated 5 - 10% fines, contains fine to coarse gravel, probable TERRACE material, fine to coarse gravel consists of rounded quartz rock fragments (continued)	SP-SM			1 1	S-12, SPT 7+4+6+10 REC=22", 92	%

39.0 -	39.0 - 45.0 ft: ELASTIC SILT; moist, dark grayish green and bluish gray, high plasticity, probable COASTAL material		- - 16.0 -		_ 40 _			
_		мн						
_					1. /	S-13, SPT 4+6+11+12 REC=24", 10	0% LL = 55 PL = 33 MC = 34.7%

45.0	Bottom of Boring at 45.0 ft.		— -22 .0—		45			
	Boring terminated at selected depth. Boring backfilled with bentonite upon co	mpletion.

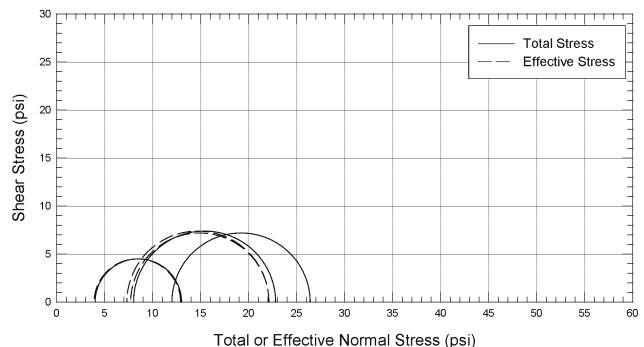
Mohr Stress Circles at Maximum Deviator Stress Criterion

Consolidated Undrained (CU) Triaxial Shear (ASTM D4767)

Boring No.: *B-02* Depth: 10-14 ft Elevation: 12 to 8 ft SE Contract: 14221002.01 Date: 9/30/14 Sample Description: *FAT CLAY (CH), contains sand, mottled light gray and light brown* Reviewed By: *CJS* Specimen Type: *Tube Sample* Gs: 2.70 (assumed) LL: 60 PI: 37 %<200: 97.9

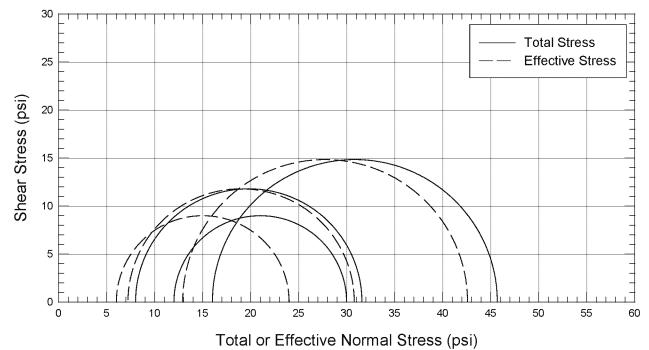
Mohr Stress Circles at Maximum Deviator Stress Criterion

Consolidated Undrained (CU) Triaxial Shear (ASTM D4767)

Boring No.: *B-02* Depth: 27-29 ft Elevation: -5 to -7 ft SE Contract: 14221002.01 Date: 9/30/14 Sample Description: SANDY LEAN CLAY (CL), contains gravel, blue gray Reviewed By: CJS Specimen Type: Tube Sample Gs: 2.70 (assumed) LL: 49 PI: 30 %<200: 52.4

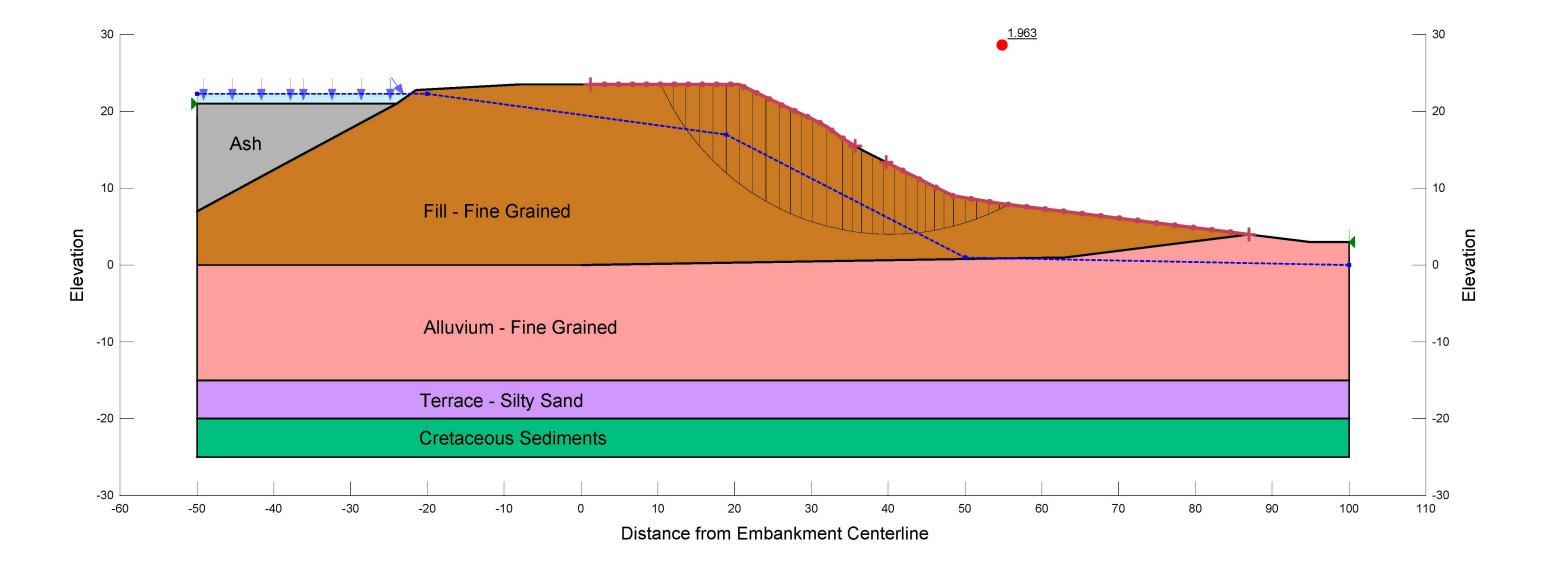
Name: FILL - Fine Grained (effective stress) Model: Mohr-Coulomb Unit Weight: 135 pcf Cohesion': 230 psf Phi': 23 ° Phi-B: 0 ° Piezometric Line: 1

Name: Cretaceous Sediments (effective stress) Model: Mohr-Coulomb Unit Weight: 130 pcf Cohesion': 300 psf Phi': 34 ° Phi-B: 0 ° Piezometric Line: 1

Table 4 presents the results of our stability analyses for each cross section and load case analyzed. The stability analysis results, including embankment section geometries, soil strata, and critical failure planes, are presented in Appendix C. The calculated factors of safety for Load Cases 1 through 3 at the sections analyzed meet US Army Corps of Engineers criteria for embankment slope stability (USACE, 2003).

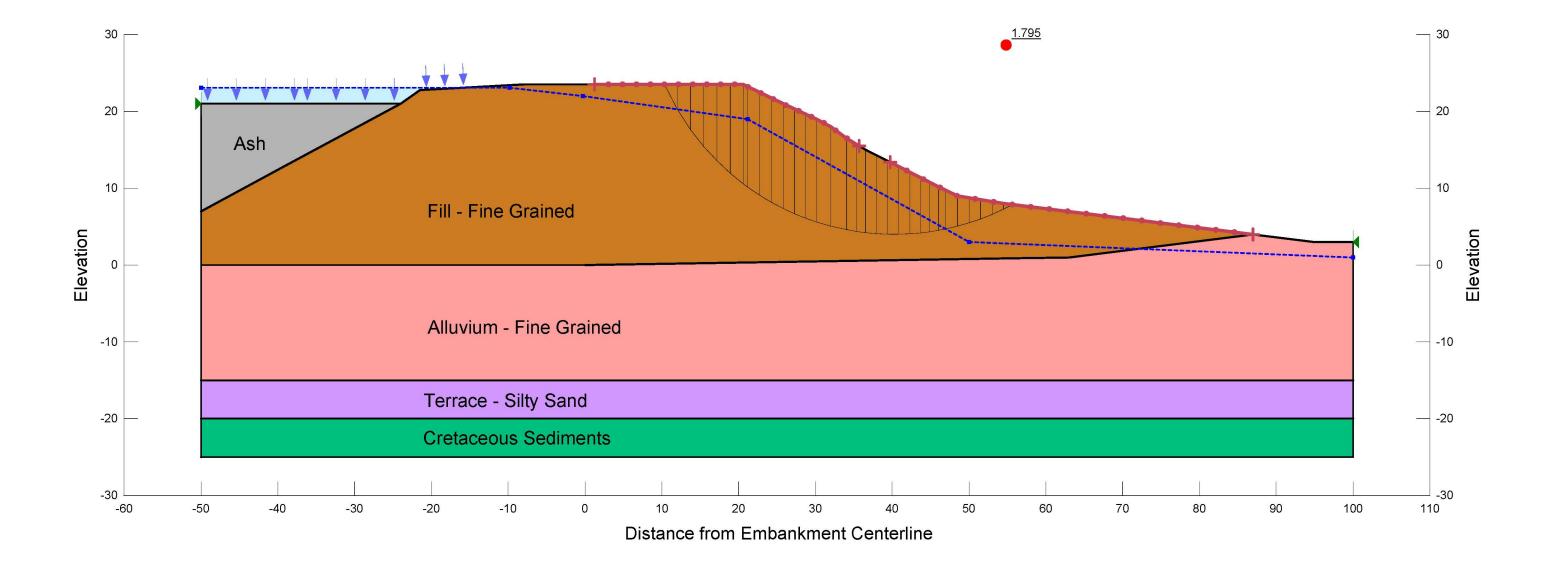
File: Possum Point ABC Slope - B-2_ Proposed - Rev2.gsz Analysis Name: b - DSP - Static Design Surcharge Pool Method: Morgenstern-Price

Name: FILL - Fine Grained (effective stress) Model: Mohr-Coulomb Unit Weight: 123 pcf Cohesion': 230 psf Phi': 23 ° Phi-B: 0 ° Piezometric Line: 1

Name: Cretaceous Sediments (effective stress) Model: Mohr-Coulomb Unit Weight: 130 pcf Cohesion': 300 psf Phi': 34 ° Phi-B: 0 ° Piezometric Line: 1

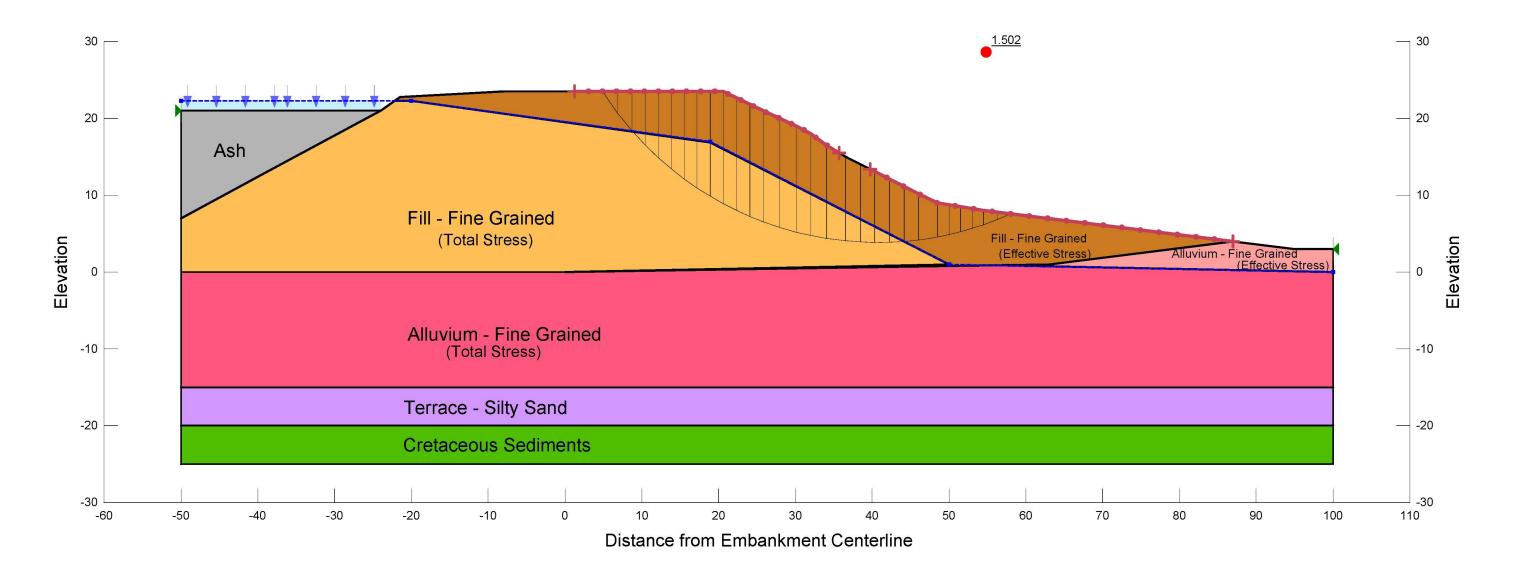
Analysis Name: c - NP - Pseudostatic Normal Pool

Name: FILL - Fine Grained (total stress) Model: Mohr-Coulomb Unit Weight: 123 pcf Cohesion': 290 psf Phi': 14° Phi-B: 0°

Name: Alluvium - Fine Grained (total stress) Model: Mohr-Coulomb Unit Weight: 125 pcf Cohesion': 530 psf Phi': 17° Phi-B: 0°

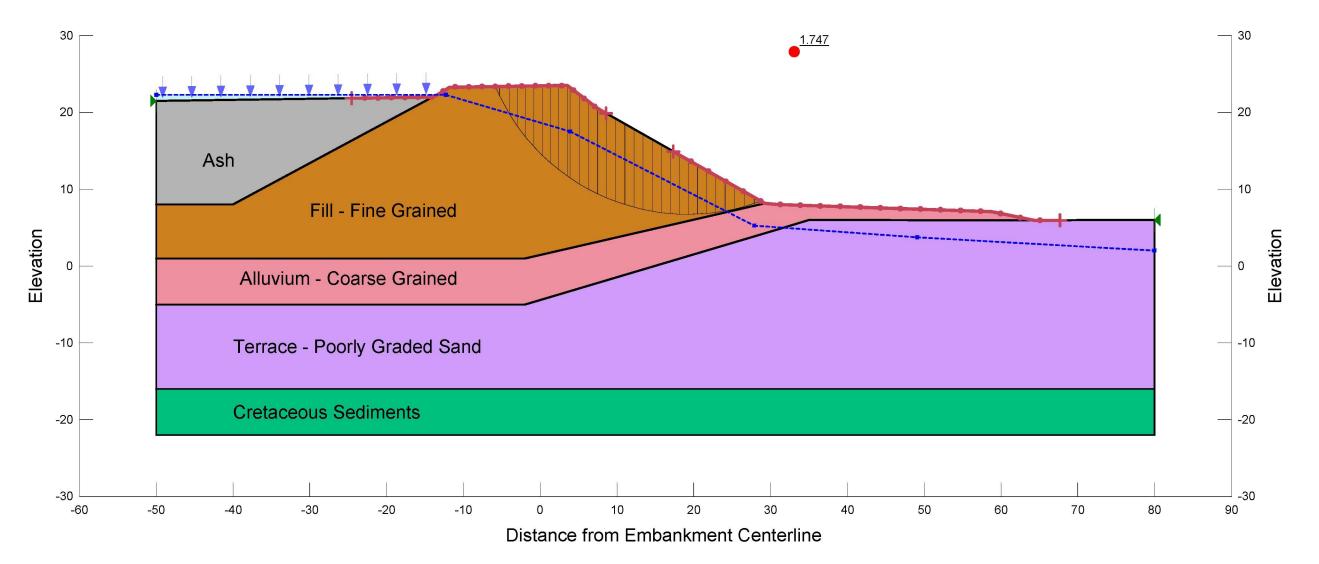
Name: a - NP - Static Normal Pool

Name: Terrace - Poorly Graded Sand Model: Mohr-Coulomb Unit Weight: 135 pcf Cohesion': 0 psf Phi': 36° Phi-B: 0° Piezometric Line: 1

Name: Alluvium - Coarse Grained (effective stress) Model: Mohr-Coulomb Unit Weight: 125 pcf Cohesion': 200 psf Phi': 32° Phi-B: 0° Piezometric Line: 1

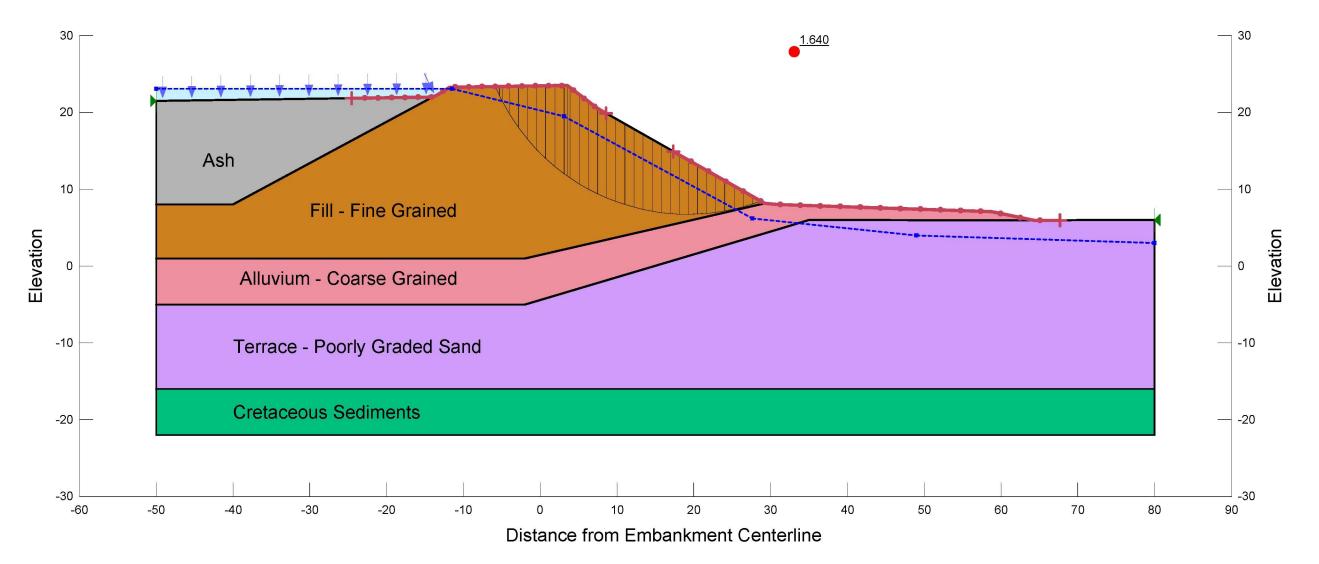
Name: b - DSP - Static Design Surcharge Pool

Name: Terrace - Poorly Graded Sand Model: Mohr-Coulomb Unit Weight: 135 pcf Cohesion': 0 psf Phi': 36° Phi-B: 0° Piezometric Line: 1

Name: Alluvium - Coarse Grained (effective stress) Model: Mohr-Coulomb Unit Weight: 125 pcf Cohesion': 200 psf Phi': 32° Phi-B: 0° Piezometric Line: 1

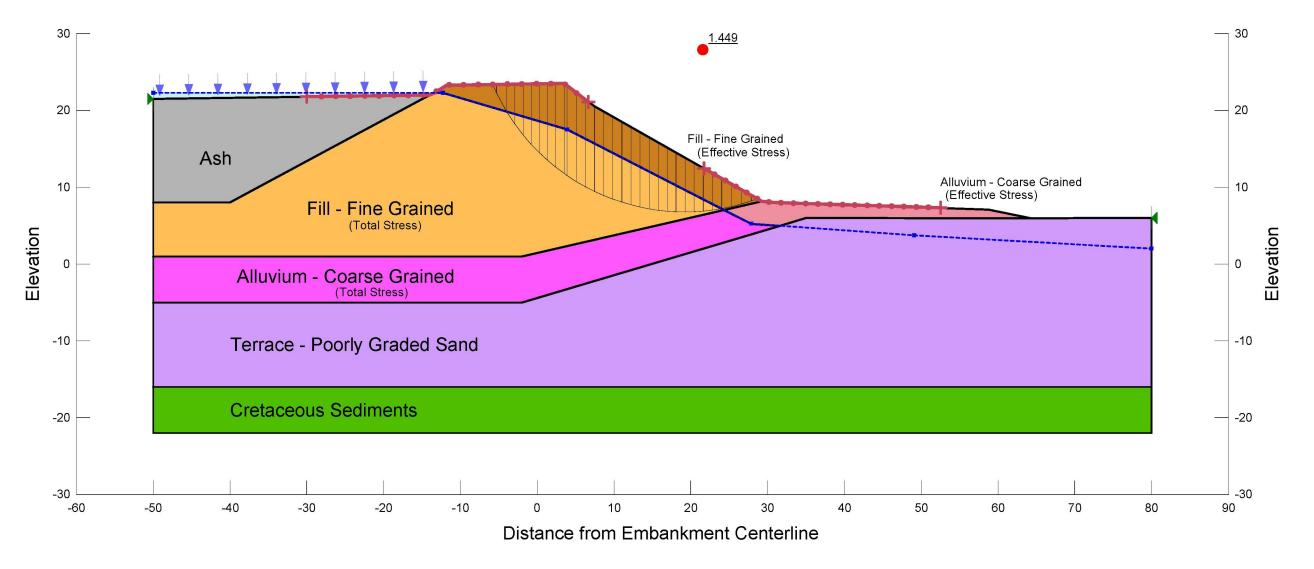
Name: c - NP - Pseudostatic Normal Pool

Name: Sluiced Ash Model: S=f(overburden) Unit Weight: 110 pcf Tau/Sigma Ratio: 0.3 Minimum Strength: 100 Piezometric Line: 1
Name: FILL - Fine Grained (effective stress) Model: Mohr-Coulomb Unit Weight: 123 pcf Cohesion': 230 psf Phi': 23° Phi-B: 0°
Name: Terrace - Poorly Graded Sand Model: Mohr-Coulomb Unit Weight: 135 pcf Cohesion': 0 psf Phi': 36° Phi-B: 0° Piezometric Line: 1
Name: Alluvium - Coarse Grained (effective stress) Model: Mohr-Coulomb Unit Weight: 125 pcf Cohesion': 200 psf Phi': 32° Phi-B: 0°
Name: FILL - Fine Grained (total stress) Model: Mohr-Coulomb Unit Weight: 123 pcf Cohesion': 290 psf Phi': 14° Phi-B: 0°

Name: Alluvium - Coarse Grained (total stress) Model: Mohr-Coulomb Unit Weight: 125 pcf Cohesion': 300 psf Phi': 18 ° Phi-B: 0 ° Name: Cretaceous Sediments (total stress) Model: Mohr-Coulomb Unit Weight: 130 pcf Cohesion': 3,000 psf Phi': 0 ° Phi-B: 0 °
